# GOES 2022

## The Great Orme Exploration Society

### Ty Gwyn to Tyn y Fron

A Project to  
Improve Access for Visitors and  
Reconnect Adit with Shaft

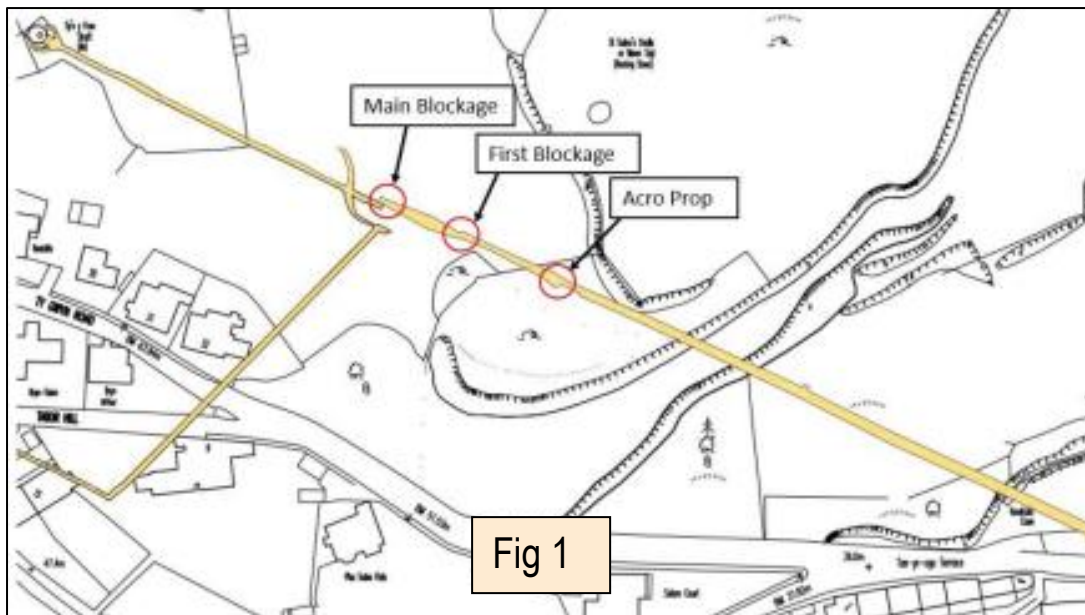
The ultimate goal of this new project is to clear the Ty-Gwyn adit so that it will be possible to walk underground from the pier entrance to the Tyn y Fron shaft. This is currently being prevented by two major blockages. See Fig 1. The 'First' blockage is passable via a small crawl passage, through which, access to the 'Main' blockage is achieved. The 'Main' blockage despite several attempts in the past by the GOES to break through, is still impassable.

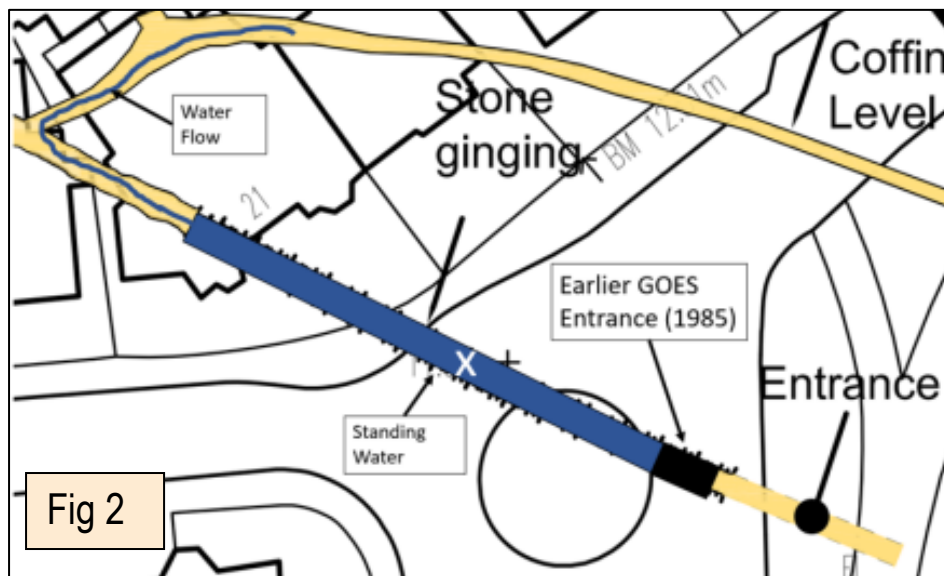
Water is raining through the ginging just after the original GOES entrance 77 feet along the adit. See Fig 2. There is also a strong smell of sewage and a large amount of standing water in this area. The water level has risen such that it is now flowing around into the Coffin Level. It appears that the floor height of the adit is raised in the location of the original GOES entrance and is holding back this water. The water is believed to be coming from a broken / leaking

waste water pipe which crosses over the top of the adit illustrated as a 'X' in Fig 2. Adrian Hughes is contacting Welsh Water to inform them of this problem.

Work to be carried out: - To dig a trench through the original GOES entrance area, lay a pipe in this trench and then back fill leaving an even walking surface. This pipe will allow the water to drain down past the current entrance and into the 'welly wash' area where I believe, it will find its way out.

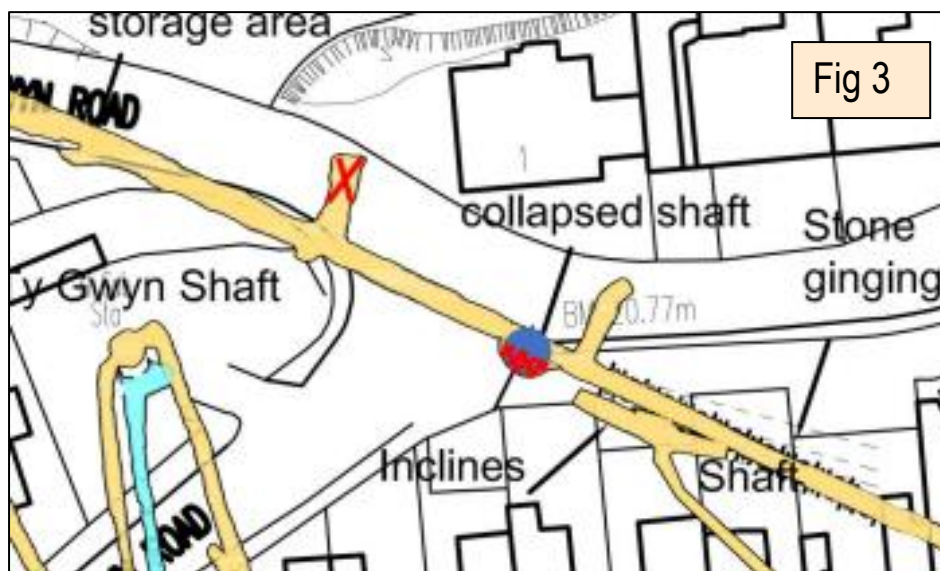
As we move along the adit we reach a large heap of spoil left over from a collapsed shaft. See Fig 3. This is also holding back water. The main bulk of this water is coming through the ceiling of the stone-built storage area further along the adit.

Work to be carried out: - Reduce the height of this hump down to adit level. The spoil will be stored in sandbags at the locations marked by red crosses on the diagram illustrated in Fig 3.

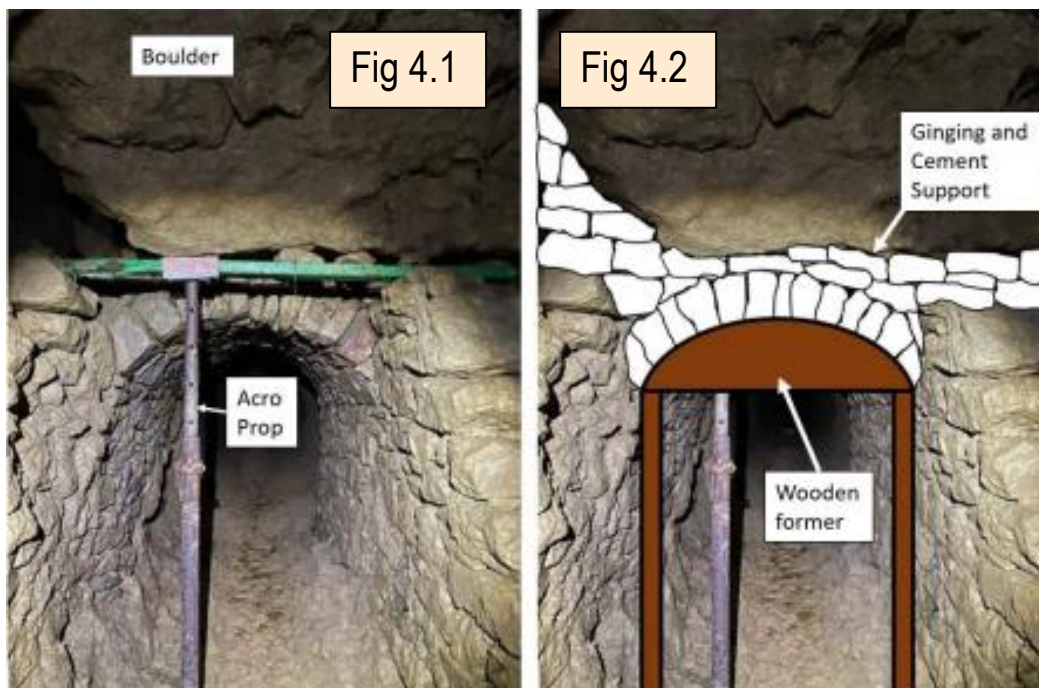
As we get closer to the 'First' blockage we pass an acro prop. See Fig 4.1. Some years earlier this prop was installed to offer support to a large boulder that's broken away from the adit ceiling. The boulder appears to be wedged and minus any further cracking, seems locked in position.

Work to be carried out: - Remove the acro prop and fully support the boulder with cement and stone. Using a wooden former, deads will be cemented into an archway matching the existing ginging. Once dried, the former can be removed and more stone will be cemented around the boulder. See Fig 4.2.

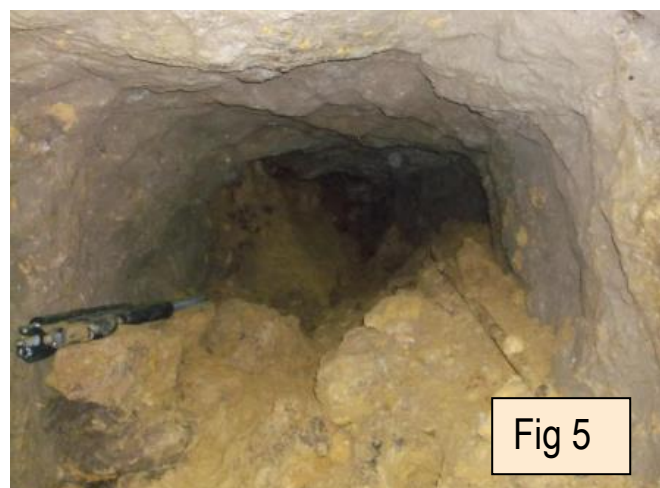
Before we can tackle 'Stage 2' (Clearing The 'First' Blockage), there is a large amount of clay, mud and stone that must be moved out of the way first. See Fig 5. The adit is wide leading up to the First Blockage and the stone can be piled along the left-hand side of the adit there. If we extend the newly created ginging described above at Location 3, the clay can be bagged and stacked above this ginging as the adit ceiling here is high.

Work to be carried out: - Remove the stone and clay up to the First Blockage providing a clear working face for Stage 2 of this project.

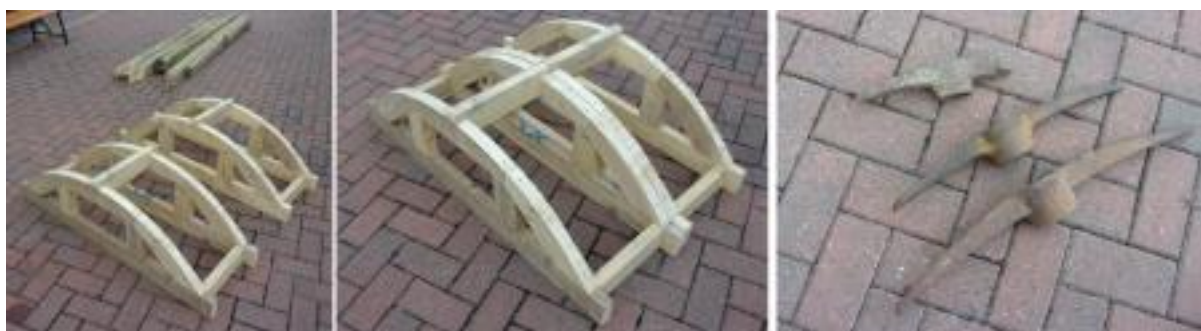
Today work started on the ginging former frames. Taking measurements from the cardboard template they are 46" wide and have an arch depth of 12". I have made them 14" long so ensuring they fit through the entrance manhole. Two have been made to sit back-to-back and enough wood is left to make a third should it be required.

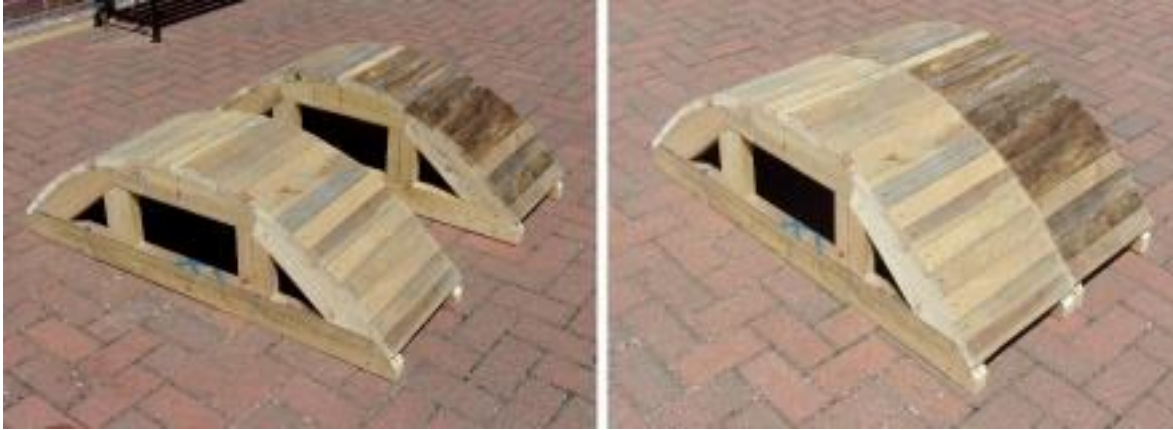
I finished the formers using a couple of donated pallets. The pallet slats were ripped down to correct width / length and then nailed onto the outside circumference of the arch former.

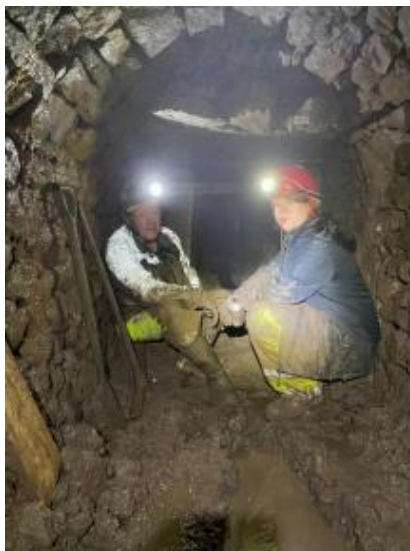
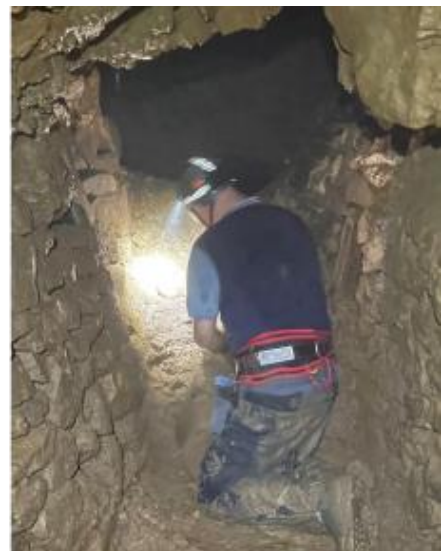
**Third work event.** Myself, Adrian Hughes and Dani Potts attended for a duration of approx. 2 hours. I continued to dig the trench at Location 1, while Adrian and Dani made some hefty progress at Location 2 (the Hump).

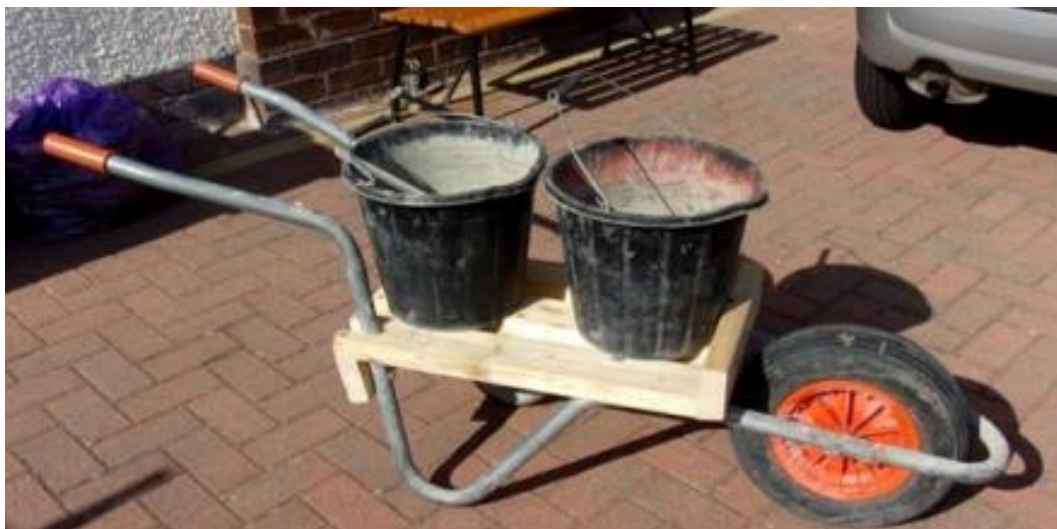
I stripped the plastic shell off the broken barrow and took the chassis to the mine entrance to see if it would fit down the hole. I noted that the sides needed to be pulled in slightly and overall, could not measure more than 14" wide. Then, from the leftover 4x2 from the ginging former frames, I made a new base for the barrow that could carry two buckets. Total cost £0.00.

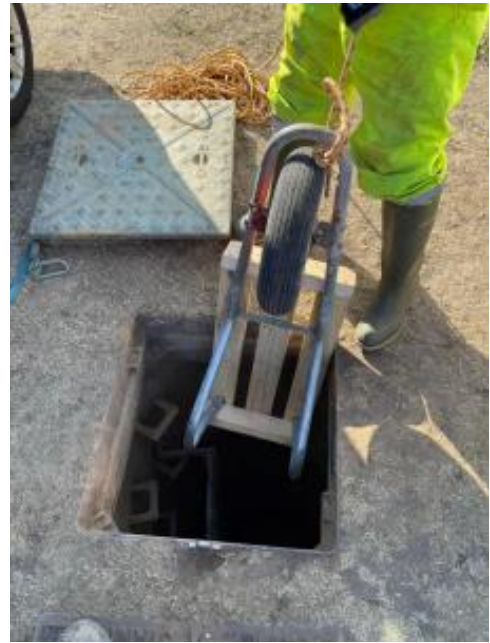
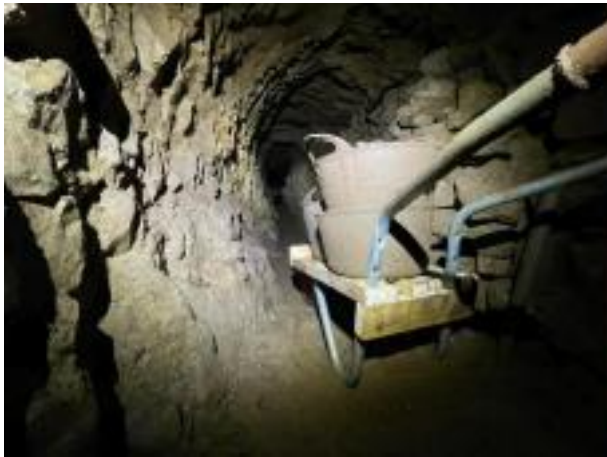
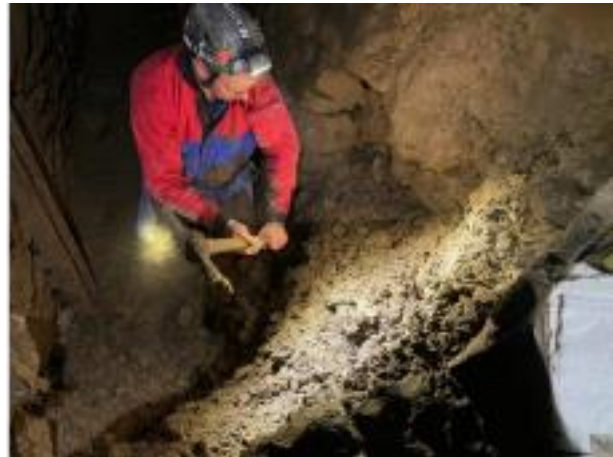
**Fifth work event.** Starting at 6.00pm, Dani, Adrian, myself lowered the new barrow through the hole and down into the mine.

We were then joined by new member Phil and all four concentrated our efforts on clearing the Hump. Adrian, now digging with the new pick made impressive progress. We are almost halfway through it now. Dani and Phil transported the spoil along the adit using the new barrow dumping it in the alcove. This has been a huge improvement as multiple buckets can now be moved with ease. I continued moving the collapse spoil and sandbags further back from the top of the ginging. We finished at 8.00.

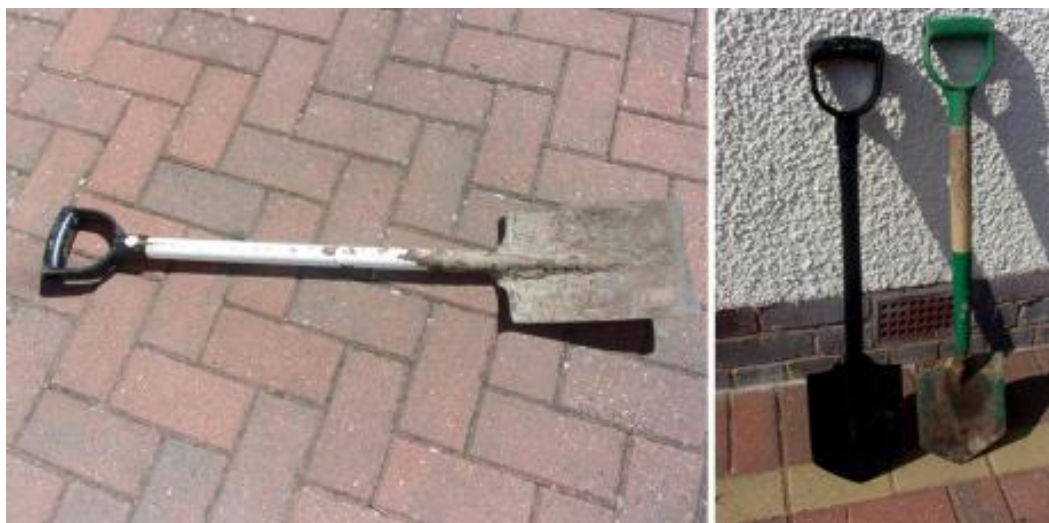
Another peek inside the tool bin of my favourite skip shop at Mochdre revealed a nice steel-handled shovel (white handled one below). Got to have that, as it was only £1. I cut 6" off the length, reprofiled the blade and give it a coat of black paint. The green one below was a spade that I'd broken some years ago. I reprofiled that blade and refitted the original shortened handle..... a pair of beauties for the total cost of.... £1.

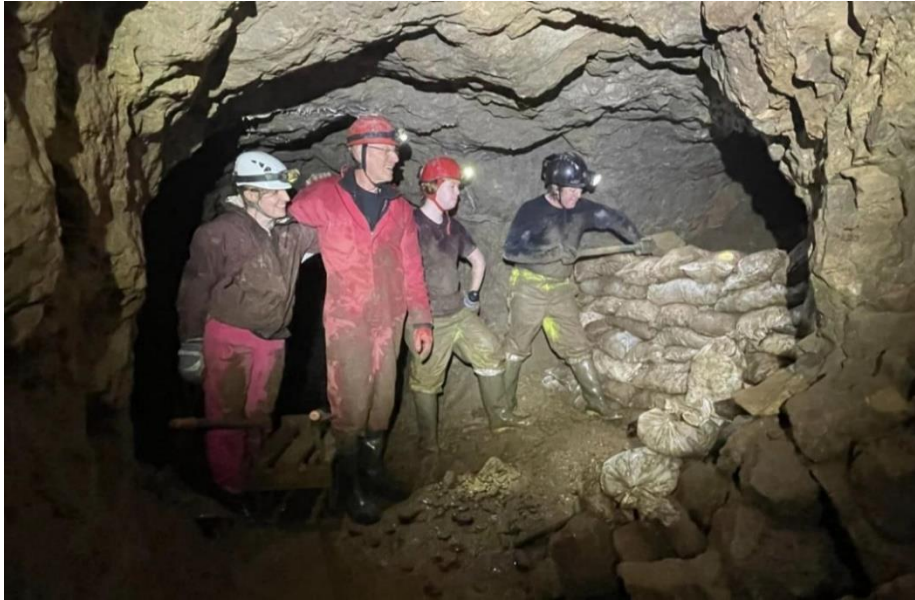
**Tenth work event.** Starting at 6.00pm, A team of five into Ty Gwyn this evening. GOES Chair Dave Wrennall and his daughter Elin joined myself, Dani and Adrian in moving the sandbags and spoil off the leaning stone wall. The old sandbags we uncovered have been repurposed, they are now shoring up the spoil in the alcove. See picture below.

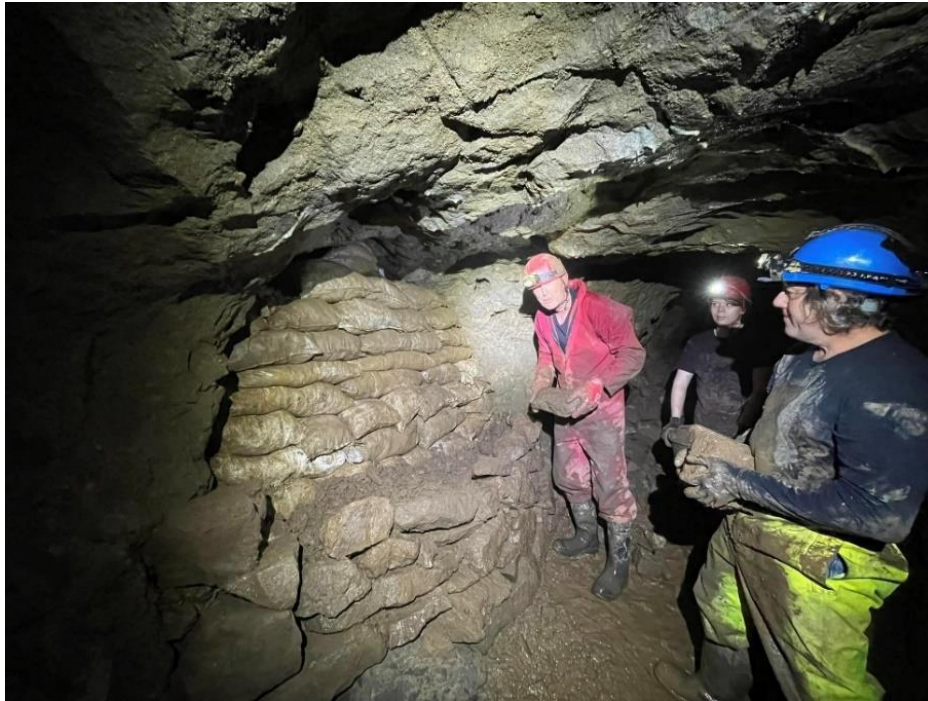
**Thirteenth work event.** 6.00pm start with Dani, Adrian, Dave W, Drew and myself in attendance. Most of the spoil from 'the Hump' has now been removed and the alcove is completely filled. Dave started to teach me how to build a 'Pack Wall' as work on the wall covering the sandbags got underway. Dani barrowed while Adrian and Drew continued digging at the Hump.

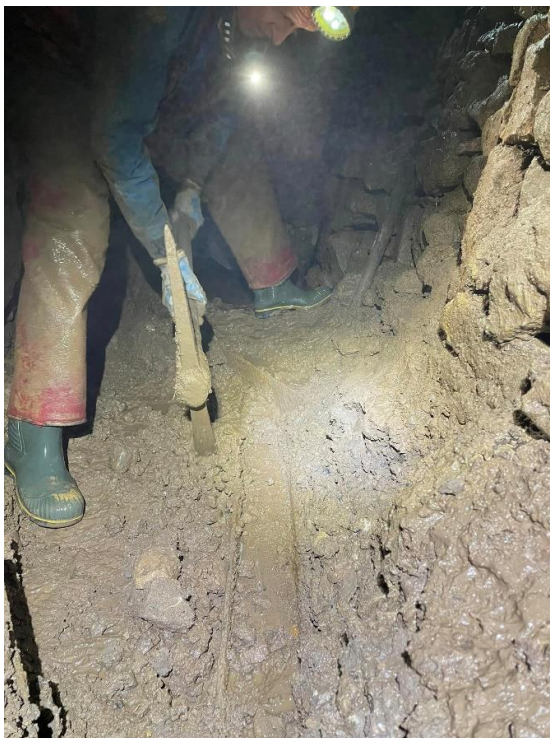
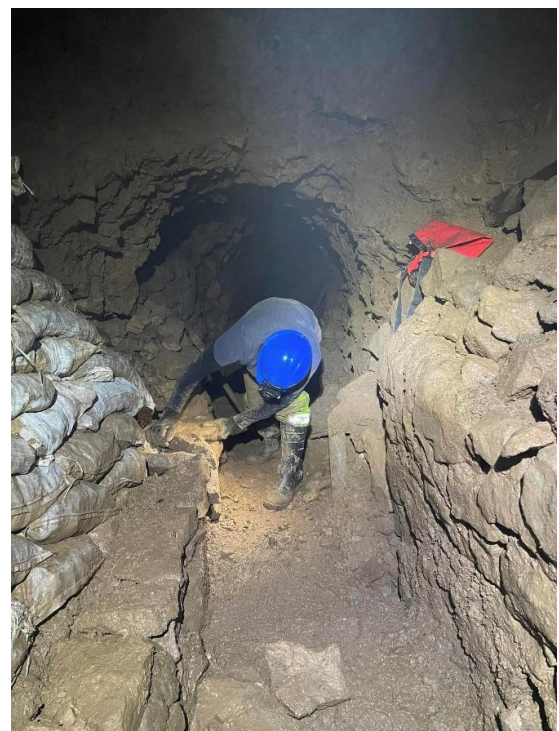
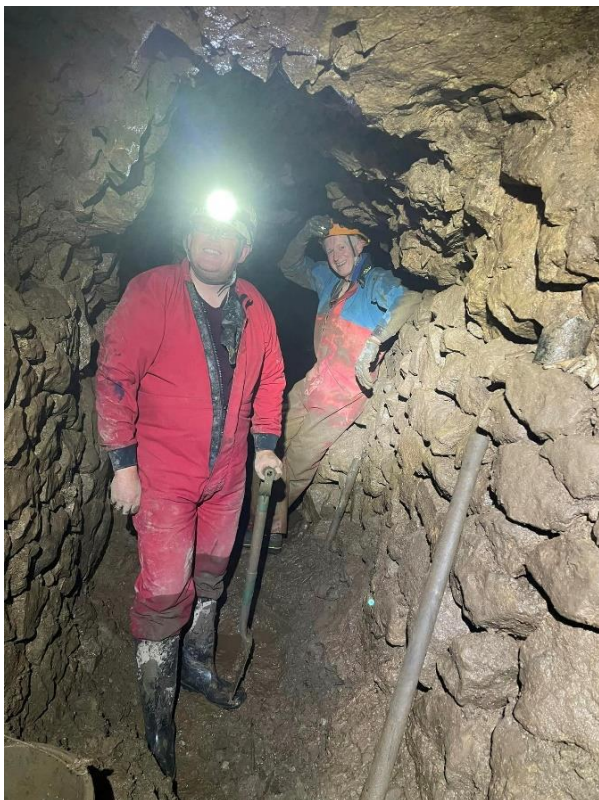
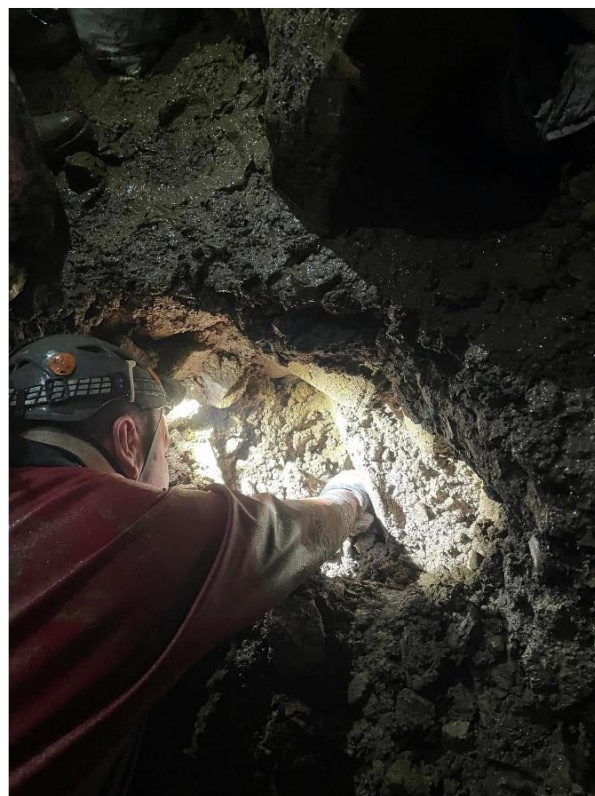
**Fifteenth work event.** 6.00pm start. Dani, Adrian and myself were joined by Rich and Rob from UCET. The dig team uncovered a large number of girders as well as more voids which we now suspect are the remnants of the incline shaft. The new sandbag wall has been completed and I started work on the pack wall to cover them.
